Manhole Inspection Summary

Manhole # S41C__033MH

Location Address: **201 sprig ct**

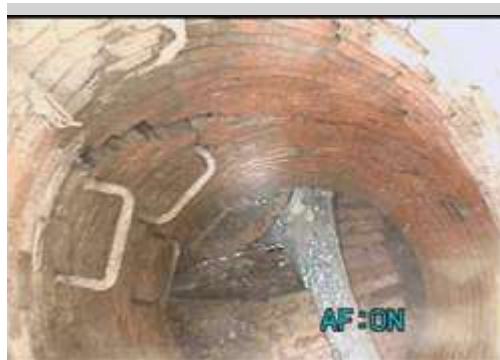
Top View

also has a view of fracture going around from corbel down to bench

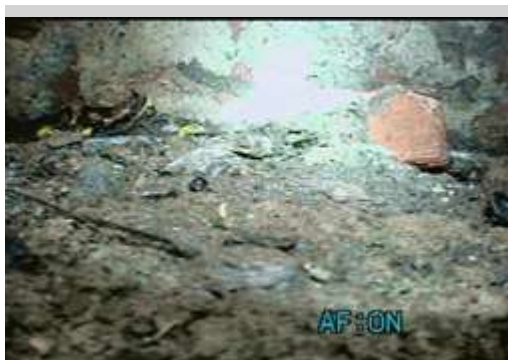
Miscellaneous

bench debris

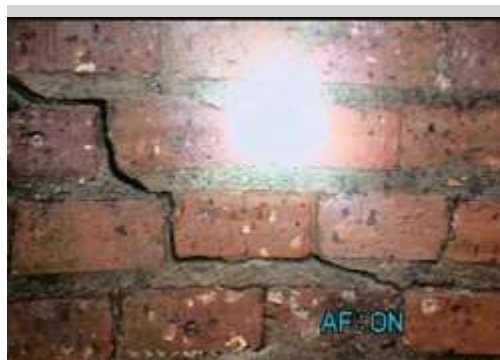
Miscellaneous

crack just above bench in barrel

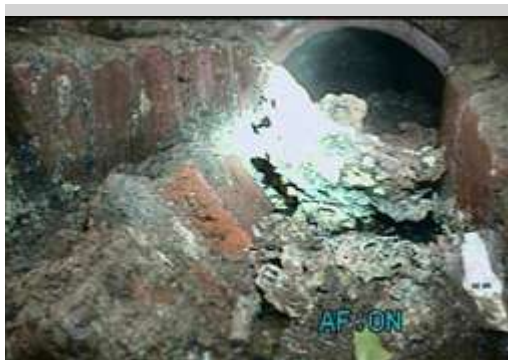
Defect 8

Condition: ☐ Sound ☐ Cracked ☐ Root Intrusion ☐ Deteriorated ☐ Leaks ☒ **Debris**

channel debris

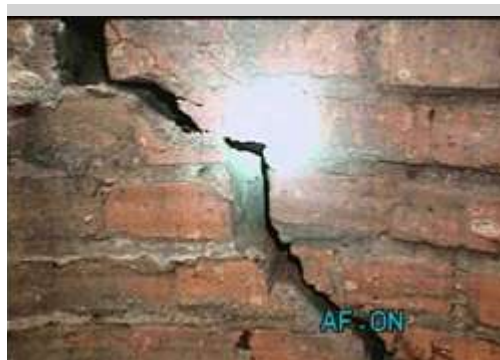
Defect 6

Condition: ☐ Sound ☒ **Cracked** ☐ Root Intrusion ☐ Loose Brick ☐ Deteriorated

fracture in barrel

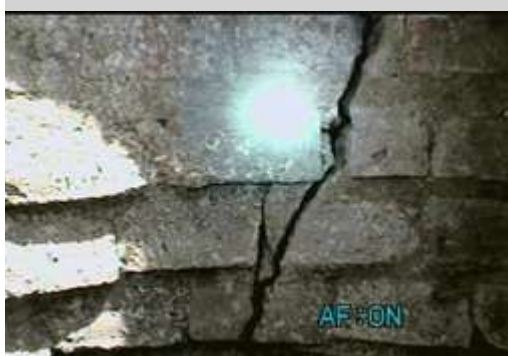
Defect 5

Condition: ☐ Sound ☒ **Cracked** ☐ Root Intrusion ☐ Loose Brick ☐ Deteriorated

another fracture in corbel

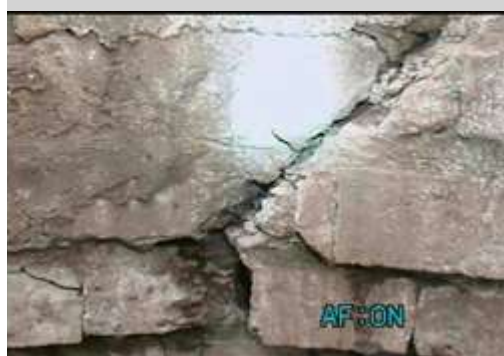
Defect 4

fracture in corbel

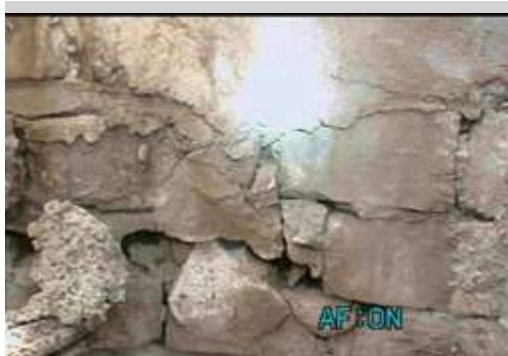
Defect 3

Condition: ☐ Sound ☒ **Cracked** ☐ Root Intrusion ☒ **Loose Brick** ☒ **Deteriorated**

chimney loose bricks, deteriorated, frame adj

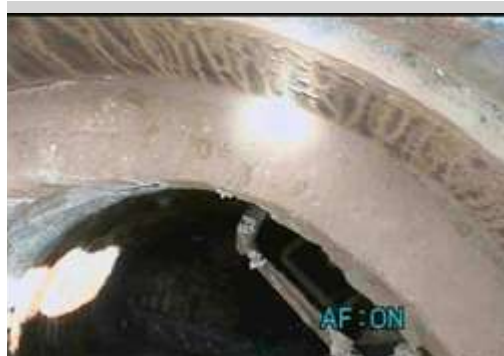
Defect 2

Offset: **4** (in.)

offset

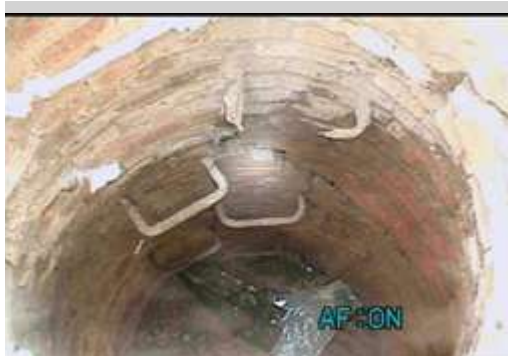
Defect 1

Infiltration: ☐ None ☐ Joint ☐ Cracks ☐ Mortar ☐ Roots ☒ **Wall**

Count: **6** Missing: **1** ☒ **Corroded**

missing/corroded steps, barrel wall infiltration

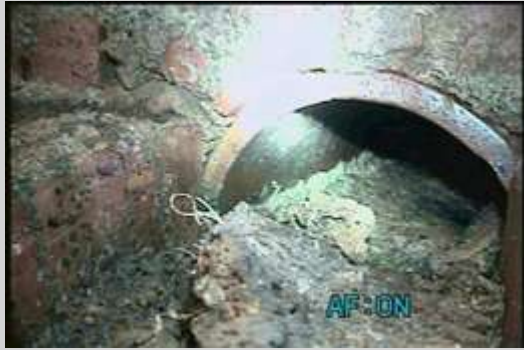
9 O'Clock Inflow

Deposits: ☐ None ☐ Mud ☐ Sludge ☒ **Debris** ☐ Grease

Silt Depth: 4 (in.) Deposits Extent: **Heavy**
